CBO Inc.
33 Four Wheel Drive Road
Carbondale, CO 81623
cell) 970-309-5259
carla.ostberg@gmail.com

Onsite Wastewater Treatment System (OWTS) Inspection 6762 Hwy 82
Garfield County, Colorado

6762 HIGHWAY 82, GLENWOOD SPRINGS

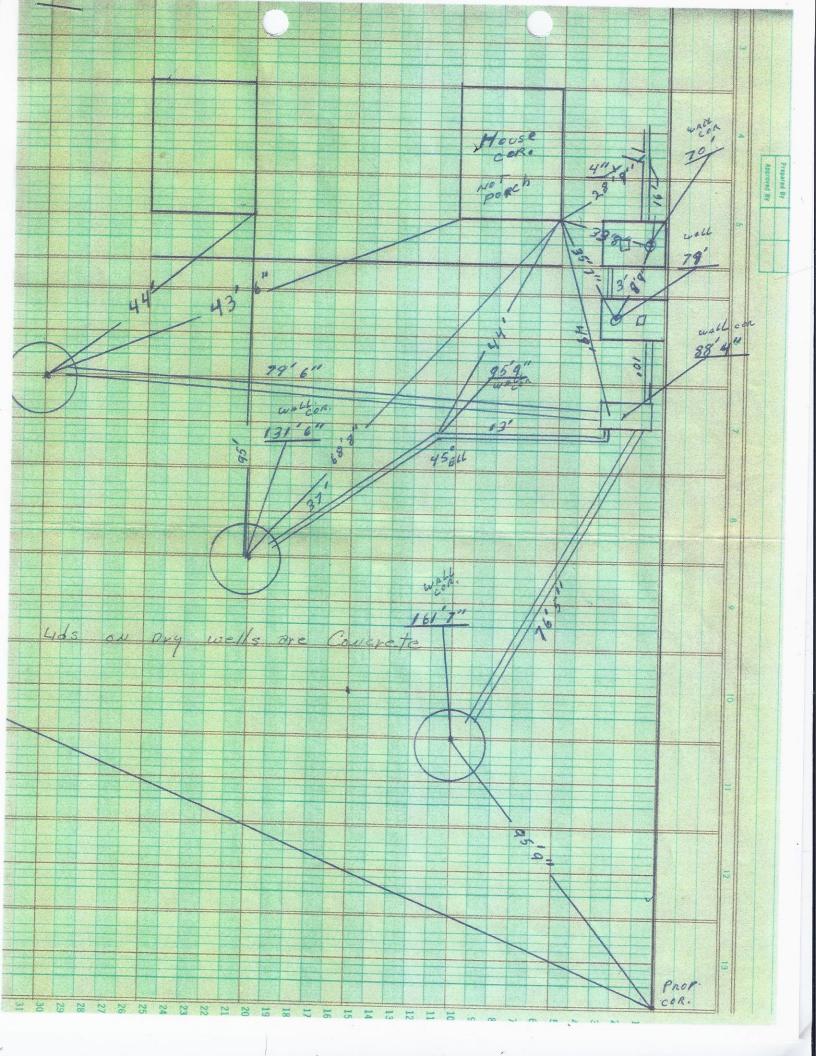
SHEET 1 OF 1

A PARCEL OF LAND SITUATED IN LOT 8 OF SECTION 1, TOWNSHIP 7 SOUTH, RANGE 89 WEST OF THE 6th P.M. COUNTY OF GARFIELD, STATE OF COLORADO
